TREE SAFETY INSPECTION

SURVEY REPORT 31 August 2025

> Flaxton Common Land Flaxton, York, YO60 7RN.

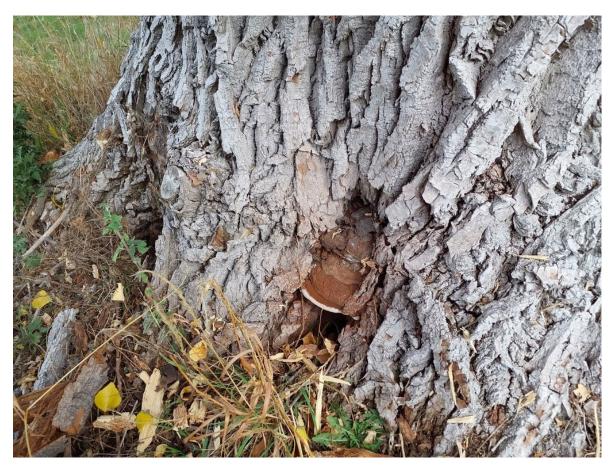
Figure 5 - Ganoderma bracket at the base of T007

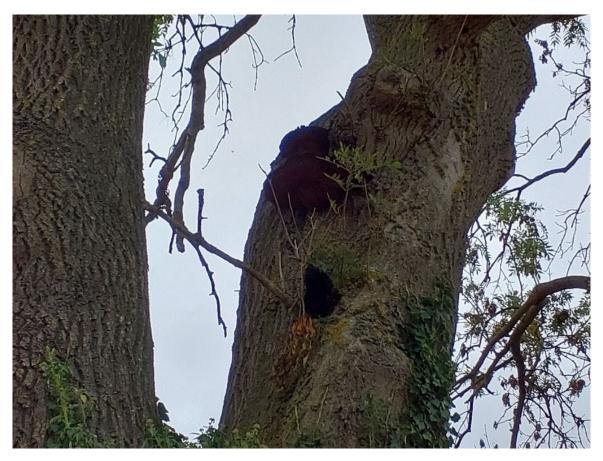
28. T044 and T045 both exhibit *Inonotus hispidus* (Shaggy Polypore) on various parts of their stems. Affect Ash wood can decay rapidly, potentially weakening branches and increasing the likelihood of breakages. While the trees are in hedgerow with generally low occupancy, benches are positioned directly beneath them, increasing the risk of anyone present if branch failure occurs. It is recommended that the benches be moved as soon as possible and that the mown footpath be relocated further south, outside the zone of potential breakages. Consideration should also be given to carrying out some level of crown reduction to further reduce the risk of branch failure. Veteranisation pruning, a specialized technique described in BS 3998:2010 Annex C, can be used to carefully manage the tree so it develops features typical of mature trees, such as hollow branches or textured bark but at a lower height. These features provide wildlife habitats and increase the ecological and landscape value of the tree over time. Given the trees' location on the edge of a conservation area, discussion with the Local Planning Authority (LPA) tree officer is advised before any such works are undertaken to ensure agreement and compliance with planning requirements.

Figure 6 - Inonotus hispidus bracket on the stem of T045.

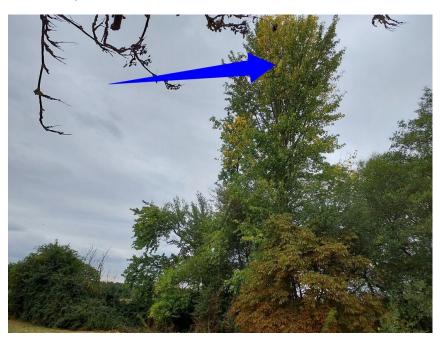
Figure 7 – Poplar tree within Group T024 to be retained

- 31. It is understood that works will be carried out in the pond areas (T024 & T037) to improve light penetration, water retention, and overall ecological conditions. Within group T024, several lower quality trees, including a snapped poplar, are proposed for removal, subject to approval and separate to this report. However, there is one Poplar tree with a higher crown than its neighbors that could ideally be retained once the surrounding understory trees have been removed.
